SteamRanger's Heritage - an insight into our past

PROBLEMS WITH 520

An insight into steam locomotive maintenance

Ian Johnston, ARHS Locomotive Manager

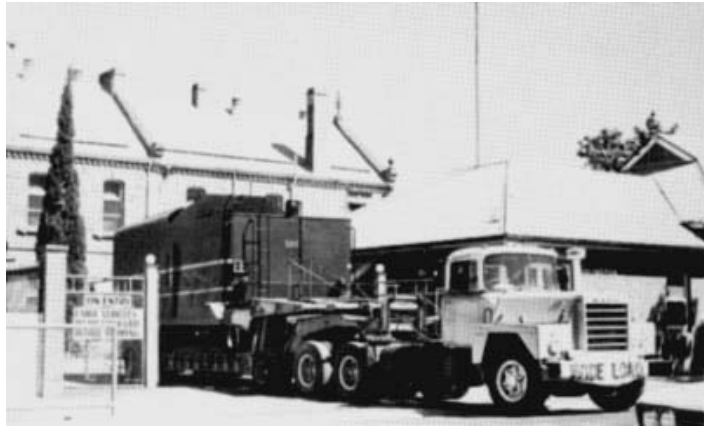
As Islington could not commit themselves to repairing the tender, quotes were sought from outside firms. However it soon became obvious that it was not practical to repair the tender due to the difficulties of welding new material to old material that had undergone a fair degree of corrosion. Various ideas and quotes were discussed and it was eventually decided that, in an endeavour to save costs, the water space only would be rebuilt and the underframe and the top plate with front curved section would be reused. An attractive quote was received and accepted from G. & R. Constructions of Dry Creek. However, because there was no rail access, the tender had to be moved by road.

Securely tied down on a low loader 520's tender leaves Islington Works

The fuel oil and water treatment tanks were removed and the tender lifted from its bogies in preparation for the transfer. F.I. & B T. Thomson supplied the low loader and in late February all 20 tonnes of the tender were moved to Dry Creek, but not without a few problems. The greatest headache was when the low loader plus tender became firmly jammed in the gateway of G. & R.'s. A mobile crane had to be summoned to lift the rear end clear of the gate. The whole transfer operation took 5 1/2 hours.

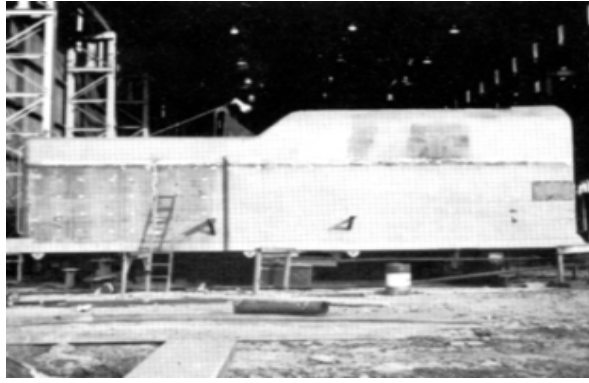
At G&Rs at Dry Creek the new tender sand blasted and ready for painting

It was unfortunate that more of the imperfections could not be filled but a compromise had to be reached with the cost and time involved.

The tender remained at G. & R.'s for 9 weeks during which time the following work was carried out:

- (a) The dimensions of the old tender were recorded.
- (b) The top section was removed by oxy-cutting
- (c) The underside of the top plate was repaired where necessary.
(This plate was still in reasonable condition).

- (d) The sides and internal baffles were cut from the underframe.
- (e) Minor repairs were carried out to the underframe which was then levelled
- (f) Replacement baffles were cut from new steel plate and welded to the underframe.

- (g) The back plate was rolled and welded to the underframe.
- (h) The side plates were positioned and welded to the underframe. Great care had to be taken dimensionally so as the top section would fit correctly,

- (i) Internal stiffeners were welded around the sides,
- (j) The internal baffle system was welded to the sides.
- (k) The complete top section was welded back into place in a rather delicate operation.

- (l) The coal bunker and crew lockers were replated.
- (m) The finished tender was sandblasted in a 6 hr. operation.
It promptly rained the next day resulting in minor rusting.

- (n) One week later, painters filled the major holes and weld marks and applied the special undercoat.

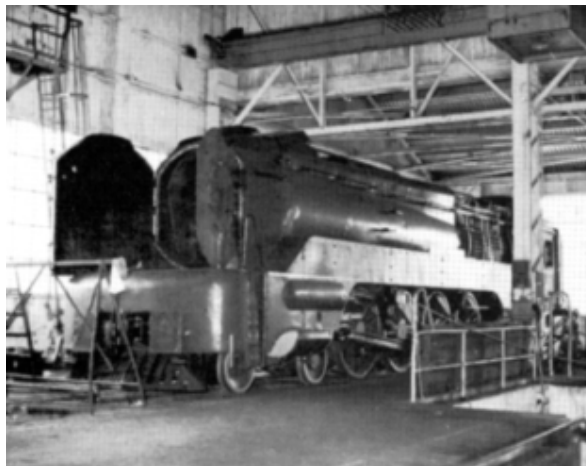
520 as Islington undergoing a boiler inspection

The result was a real calamity. Water poured from the superheater header, leaks were found from 4 boiler stays around the firebox and the boiler would only "hold" 190 psi. The leak from the header indicated either a problem with the regulator or, more seriously, a leak in the main steam pipe, a pipe which delivers the steam from the boiler to the superheater elements then to the cylinders. The dome cover was then removed but the regulator was found to be holding water OK. Things began to look grim. To replace a steam pipe was a major 5 week job even in the hey-day of steam as considerable dismantling of the locomotive was involved followed by hours of careful lapping and fitting of pipe joints.

The second hydro test was successful in one respect as no water leaked from the header at 275 psi. To this day no-one knows where the water came from during the first test, but an improperly seated regulator was suspected. The test was not so successful as a total of 10 boiler stays were now found to be cracked or broken. This was shattering news as 8 of these were 28" long rigid crown stays and no spares were available. The other two were small ball stays of which there were plenty of spares. The replacement of crown stays was never a small job. Before we knew what was required, the old stays had to be removed by a rather laborious process taking nearly two days. Meanwhile it had been ascertained that while Islington still had 50 feet of stay bolt steel and the dies to forge new stays, their forging machine was completely useless with a cracked crankshaft.

The Society purchased the steel and borrowed the dies and the Society President, Graham Bowes, made extensive enquiries to forging works in Adelaide. Only one firm, Perry Engineering, had a forge of sufficient size and were willing to attempt the job in the few days we could allow. This was good news until it was found that the dies would not fit and could not be easily adapted to fit either of their large forges. However by adapting some of their own dies, they were able to forge "heads" for 12 bolts even though extensive machining was then necessary to produce the buttonhead and taper neck bolts required. Perry's worked wonders and from scratch had the forging and heat treatment completed within 2 days.

The machining could only be done at Islington where the necessary expertise and tools were available. The machine room boys rose to the occasion and after some minor problems, had all stays machined in 3 1/4 days which included 2 nights overtime. The stays had been progressively fitted as they were machined and all stays were finally screwed and riveted into place on Friday, 12th May. The boiler was then washed out to remove scale etc. dislodged during the riveting process.

A hydro test to 275 psi was again necessary to test the new stays and to determine whether the riveting had cracked or broken other stays as quite commonly occurred years ago. It was all important for the boiler to pass this test as failure would have certainly sidelined the locomotive for the Steam Festival. Luck was with us with the boiler holding 275 psi with no problems. The next task was to steam test the boiler but before this could be done, the brick arch in the firebox had to be rebuilt and the smokebox completed.

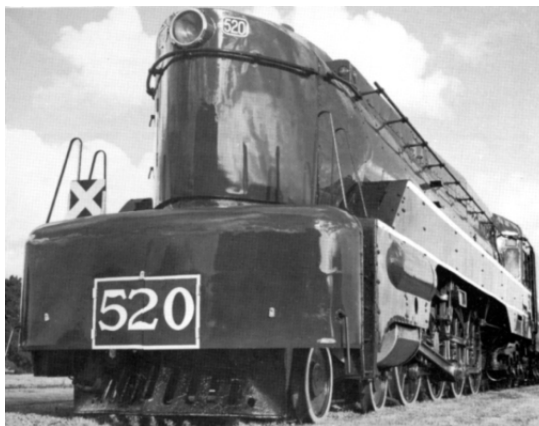
Fresh from the Islington paint shop, 520 shines in all its glory

On Friday, 23rd June, the engine was acid washed and rubbed down with steel wool in preparation for repainting. The next morning was spent removing old flaked paint then, in the afternoon, the special undercoat was applied. On Sunday, 24th June, the three coats of Hawthorn Green Dulux Acran paint were applied and the locomotive was transformed once again to a gleaming green giant. Lining out and bogie painting were carried out on the following Saturday; the weekend work being necessary because of the heavy work load on the Paint Shop at Islington.
