SteamRanger's Heritage - an insight into our past

PROJECT 520

Reported by Ian Johnston

ARHS Recorder August 1982 pages 148 - 153

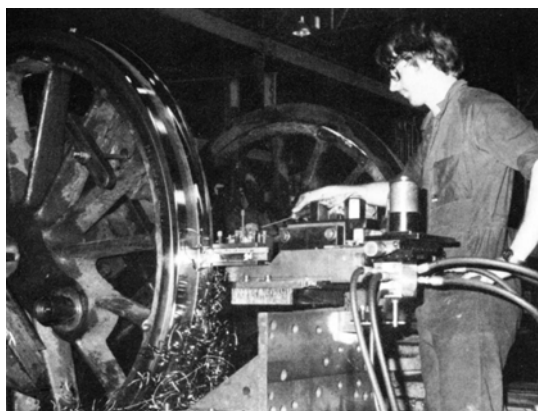
The exacting profiling task was carried out on Perry's heavy lathes
Photo: Andrew Gramp

The project gradually began to gain momentum but it still took many weeks for the heavy engineering work to progress. While it may seem simple enough to cut off the old tyres and shrink new ones to the wheels, many hours of research and planning were necessary. It is a one shot process; if you don't get it right first time, that's it — there is no opportunity to remove the tyre and start again. Consequently the machining of each tyre had to be spot on and the tyre heated to the right temperature to ensure that it did not end up being loose on the wheel or too tight thereby creating undue stresses. Once the tyres were on each wheel, the correct tread profile had to be machined so that each wheel ended up exactly the same diameter.

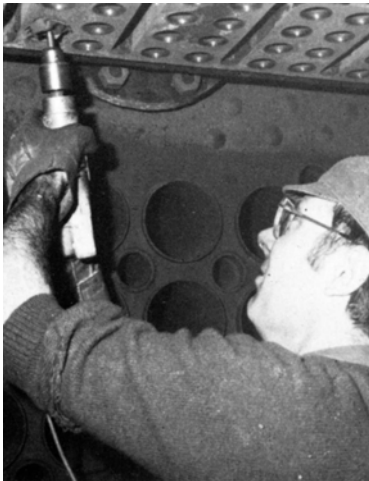
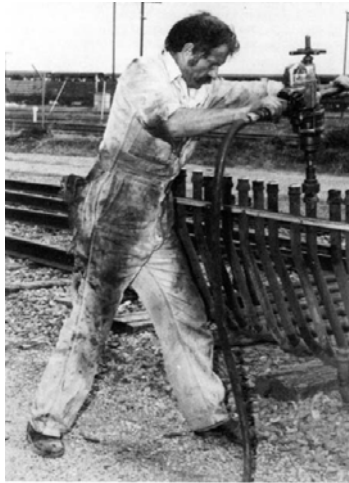
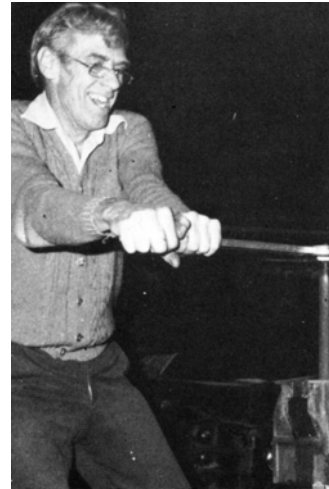
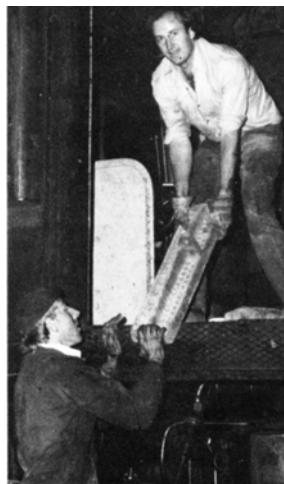
Volunteers at Dry Creek working on superheater elements (top) and installing heavy firegrates (below)
Photos: Roger Currie

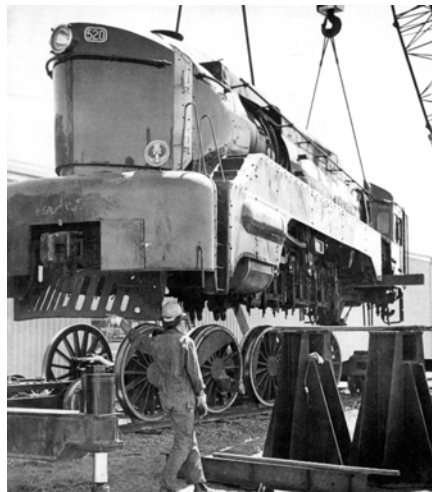
The huge bulk of 520 is steadied by one man as it is slewed towards its temporary site at Dry Creek
Photo: Roger Currie
