SteamRanger's Heritage - an insight into our past

LOCOMOTIVE 621

Report on major restoration 1979 - 1986
Reported by ARHS Locomotive Manager Ian Johnston

'The Return of the Duke'

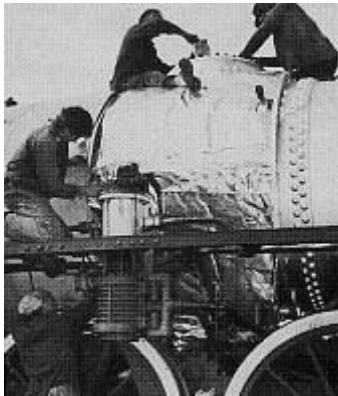
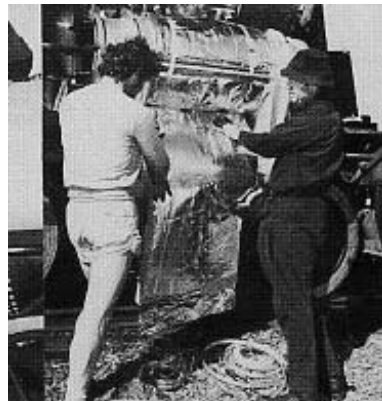
Peter Hoye and Peter Soar tightening dome cover nuts as Glen Smythe and Andrew Gramp work on insulation cladding (L) and Richard Bonney and Roger Currie fit insulation to 621's cylinders (R)

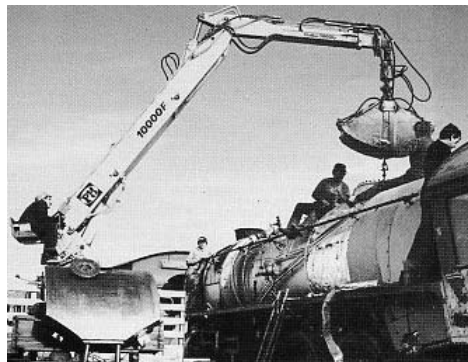
Ian Johnston on the crane, Peter Soar and Peter Hoye guide 621's dome cover into position as Ben Greeneklee looks on.
(All above photos Roger Currie)

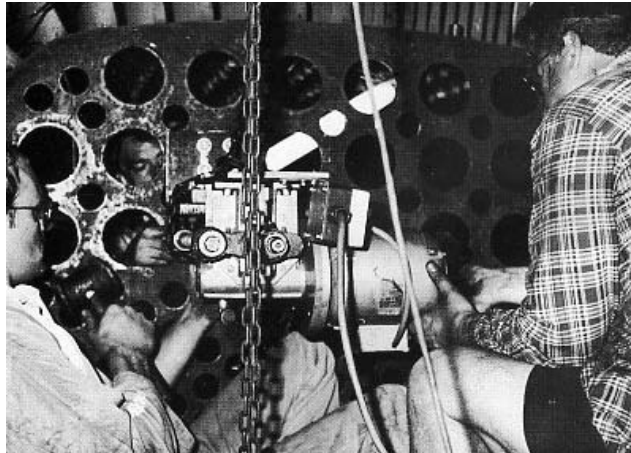
- Rebore the 22 flue holes in the firebox tubeplate to remove unacceptable levels of ovality and taper. It is suspected these resulted from attempts by Islington to correct flue-end cracks by overexpanding the flues. To expand reconditioned flues into these holes would have been a complete waste of time as good sealing would have been impossible to attain.

Reboring 621's flueholes in the firebox tubeplate.
Ian Johnston (in the firebox) sets up the special boring machine
with Peter Brown (adjusting tool at the ready) and Peter Soar at the right.
Photo: Roger Currie

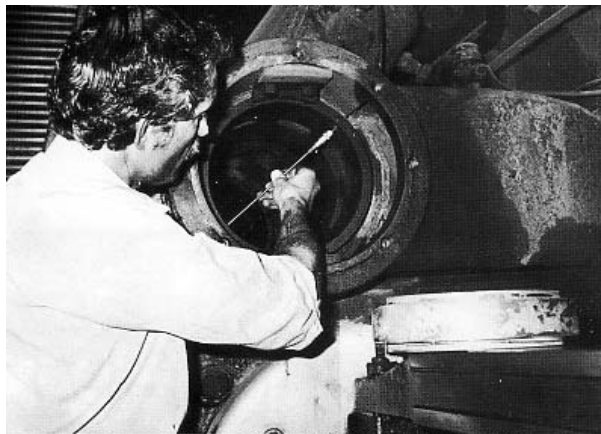
The valve cylinders were rebored some months ago. The boring machine was kindly loaned by the Pichi Richi Railway Preservation Society. The extensive grooving in the valve cylinders which gave the firemen heaps of extra work to do due to copious steam leakage has now been completely removed. The piston valve assemblies (bobbin shaped with a pair of rings at each end designed to admit and exhaust steam to and from each end of the main cylinders) proved very stubborn to dismantle. The saga began at the Depot with a 10 tonne hydraulic "porta-power" but no sign of movement. The assemblies were taken to Perry Engineering and placed in their 100 tonne press but neither would budge, even at full load. Next trick was to soak them in diesel fuel for two weeks and try again. Not bad stuff because both valves came apart at 45 tonnes. However the valve ends and bull rings as recovered were useless as extensive corrosion had taken place, for instance, one section which was supposed to be 8mm thick had wasted to 3mm. So lots of new castings were repaired and even though we have various casting patterns Murphy's Law prevailed and there were none of these. Between making new patterns and the required castings over \$1100 has been spent and this is before any machining has begun.

Ian Johnston checks measurements of the rebored valve cylinders.
Note one of the four new bull ring castings on slide bars.
Photo: Roger Currie

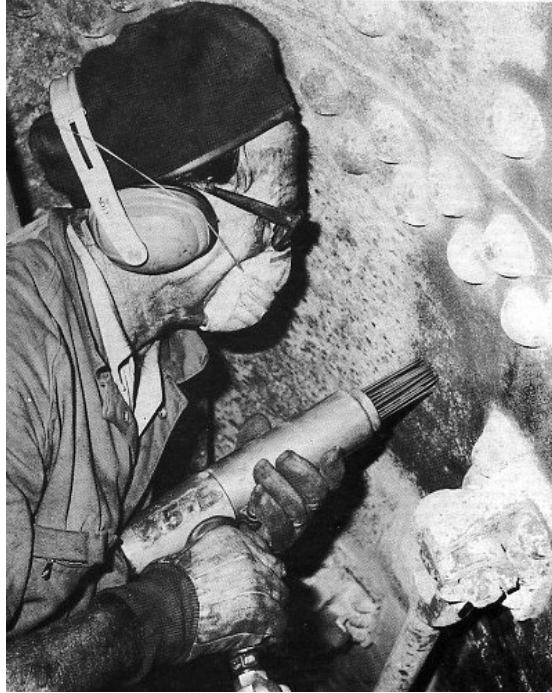
It was not until 1984 that work recommenced. The 22 flues were removed, grit blasted and the repairable ones sorted out. The remainder of the boiler clothing and fittings were removed. The condition of the boiler interior had to be seen to be believed with scale up to 12 mm thick —the result of years of neglect and improper water treatment. The removal of this scale was to be the main reason for slow progress on the boiler. It all had to be removed so that the Boiler Inspector could inspect the steel boiler shell. The interior then had to be completely Apexior painted. The flues were reconditioned which included trimming the ends, swaging one end, welding on a make-up length and welding the corrosion marks. Because of the condition of the tubeplates various combinations of flue lengths and diameters had to be worked out beforehand.

Needlegunning inside 621's boiler.
Never a popular job but Howard Johnston
has spent many hours removing layers of scale
Photo: Roger Currie

- renew the main whistle steam pipe.
- renew the top feedwater tray.
- needlegun the entire interior to remove large scale deposits after years of neglect.
- treat all non-heating surfaces with Apexior paint.
